Appendix B: Location, installation and performance data from review of cable median barrier installations in Washington state

The data sheets that follow contain information about each location where cable median barrier was installed or under construction along Washington state highways at the end of 2008. The before-and-after collision data shows the number of crashes, by severity, that occurred in the median and crossed the median in each location before and after cable median barriers were installed.

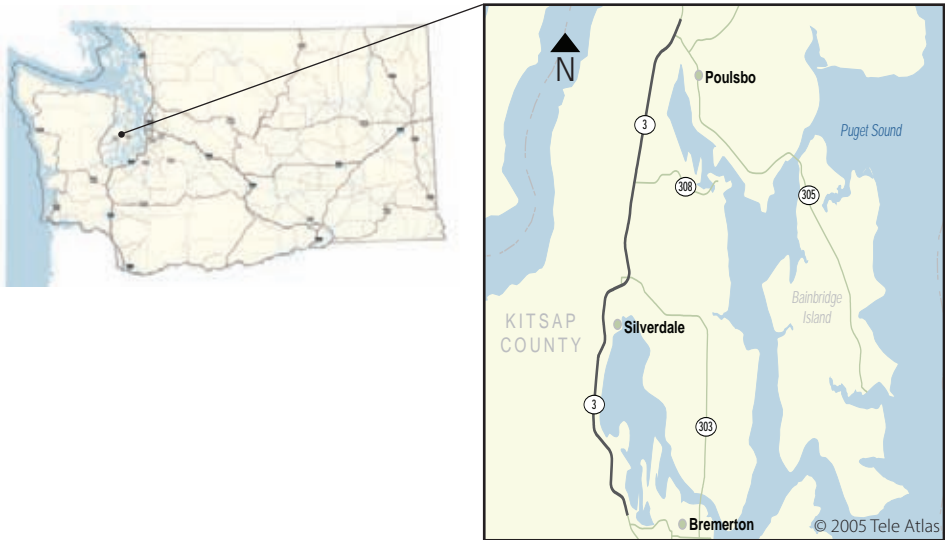
Average annual daily traffic volume

Vehicles per day by year

ADT average growth rate on segment north of Silverdale is 4 percent per year.

ADT average growth rate on segment south of Silverdale is 2 percent per year.

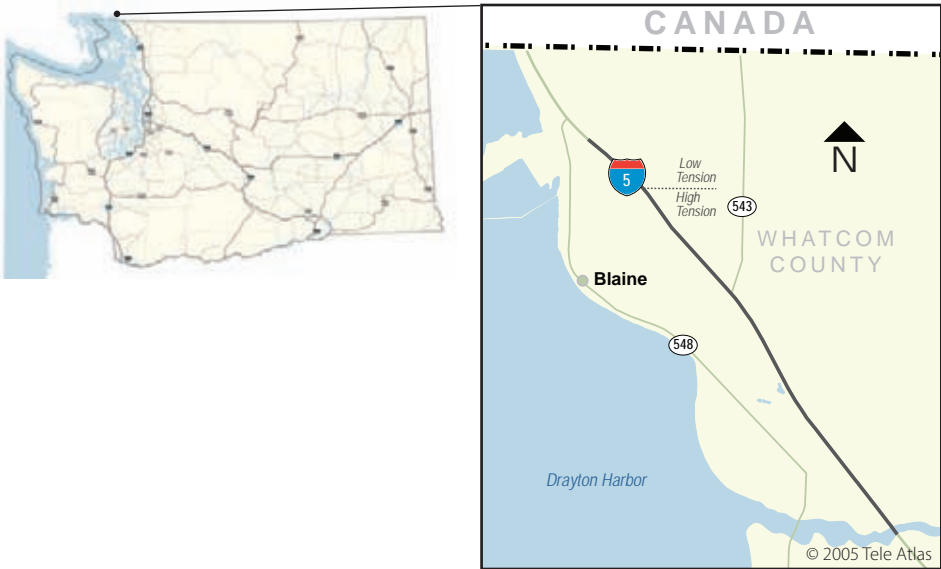
ADT average growth rate on segment is -2 percent per year.
